ECQA QUALITY | COMPLIANCE	**Inspection Report**	Conclusion **PASS**

Report Number		
Factory	Linyi Cuzi plywood Co.,Limited	
Purchase Order	/	
Item Number	21mm / 24mm / 30mm	
Product Description	PLYWOOD 100% Birch plywood, WBP, Phenolic E1 Glue, 2500x1250mm	
Order Quantity	1596pcs,1376pcs, 2548pcs	
Approval Sample is in Place	☐ Yes ☒ No	
Inspection Type	☐ PPI ☐ DPI ☒ FRI ☐ 1st Re-FRI	
General Inspection Level	Normal Single Plan, Level I☒ , II☐ , III☐	
AQL	Critical: Not Allowed; Major.: 2.5; Minor: 4.0; Sample size:80pcs	
AQL Conformed	☒ Within AQL ☐ Beyond AQL	
Address of Inspection	No.184 Huilongshan Road, Huangdao District	
Date of Inspection	2025.03.11	Arrival & Departure Time：9:00 - 16：00
Inspector	Sky Sun

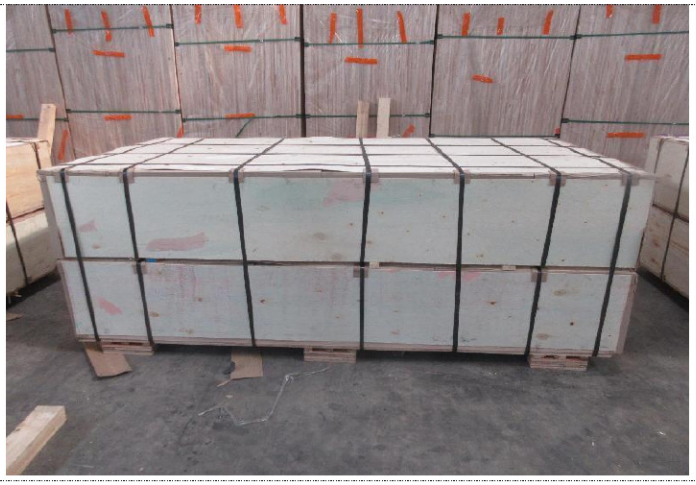
Remark Photo

The pallet label is not pasted, the factory said it will be pasted when shipping.
